# Douglas Pond and S. Bingham Pond Land Use and Water Quality Assessment Cornwall, Vermont

Landslide Natural Resource Planning P O Box 311 East Middlebury, VT 05740

December, 2014

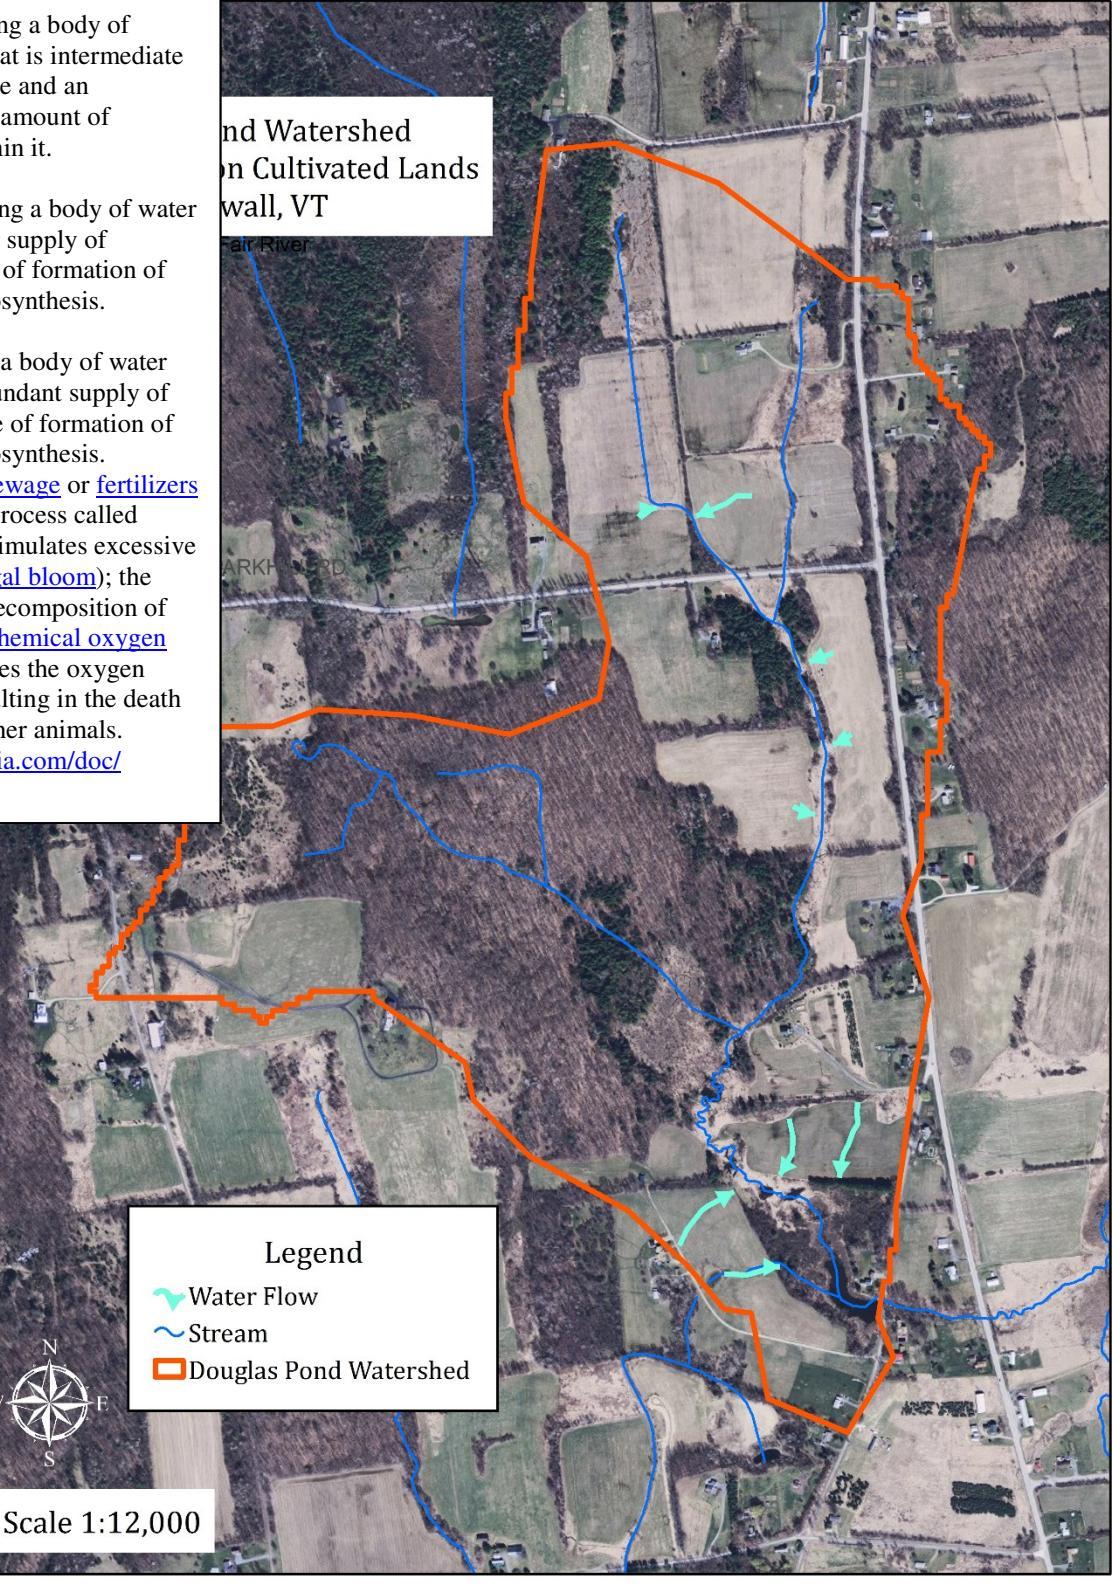
- 5. Watershed Management There are 2,700' of stream in cultivated agricultural fields that have no riparian buffer. Maintaining riparian buffers slows and filters water runoff and also slows erosion. Regardless of the other management goals, if nutrients and sediment are allowed to flow unchecked into the surface water, aquatic vegetation will continue to be present.
- 6. Planting grass swales along agricultural runoff channels identified on Map 7 will reduce and slow runoff into the stream channel.

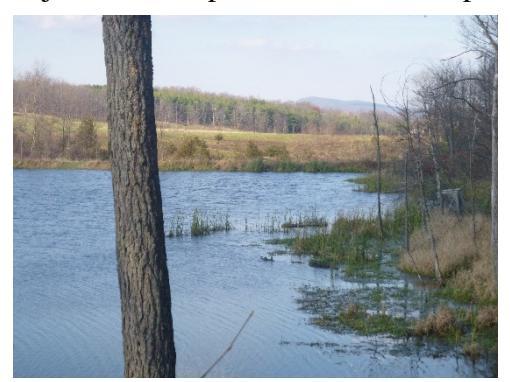
end of the west side corn field. Buckthorn is starting to invade. Fresh beaver activity was observed at the south end of the pond. On the day of the site visit, in addition to evidence of beaver, ducks, geese, deer, turkey and crows were observed at the site. On the east side and adjacent to the pond, there are two paths/slides down to the pond, presumably from beaver, that

are eroding (head cutting) at their east end. It may be a combination of shallow ground water and surface water flowing in the animal paths during high flow events is causing this erosion. The deciduous forest on the east side of the pond is fairly even aged and comprised of a mix of beech, birch and oak. An old duck blind was observed down by the water in this area as well. There is a small tributary entering the pond on the east side where mounds of soil near the mouth were observed which may indicate historic dredging. The water was clear of aquatic

vegetation on the day of the site visit. *View north from east shore*

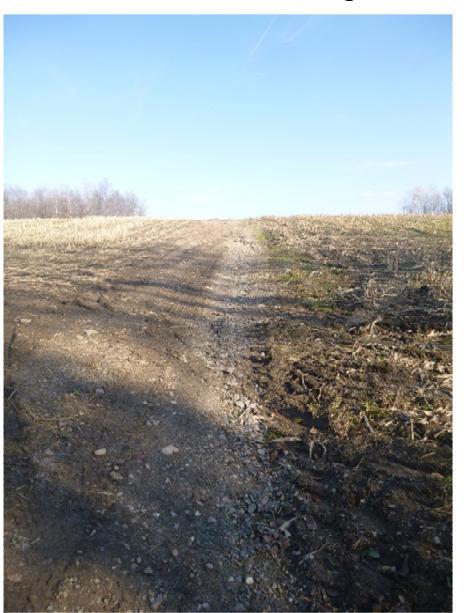
1 Erosion on VAST trail

continues east, out of the watershed and up into another cornfield, where surface water flows had eroded the road/trail. These flows likely end up in a ditch running along the south end of the VAST trail and into the pond.

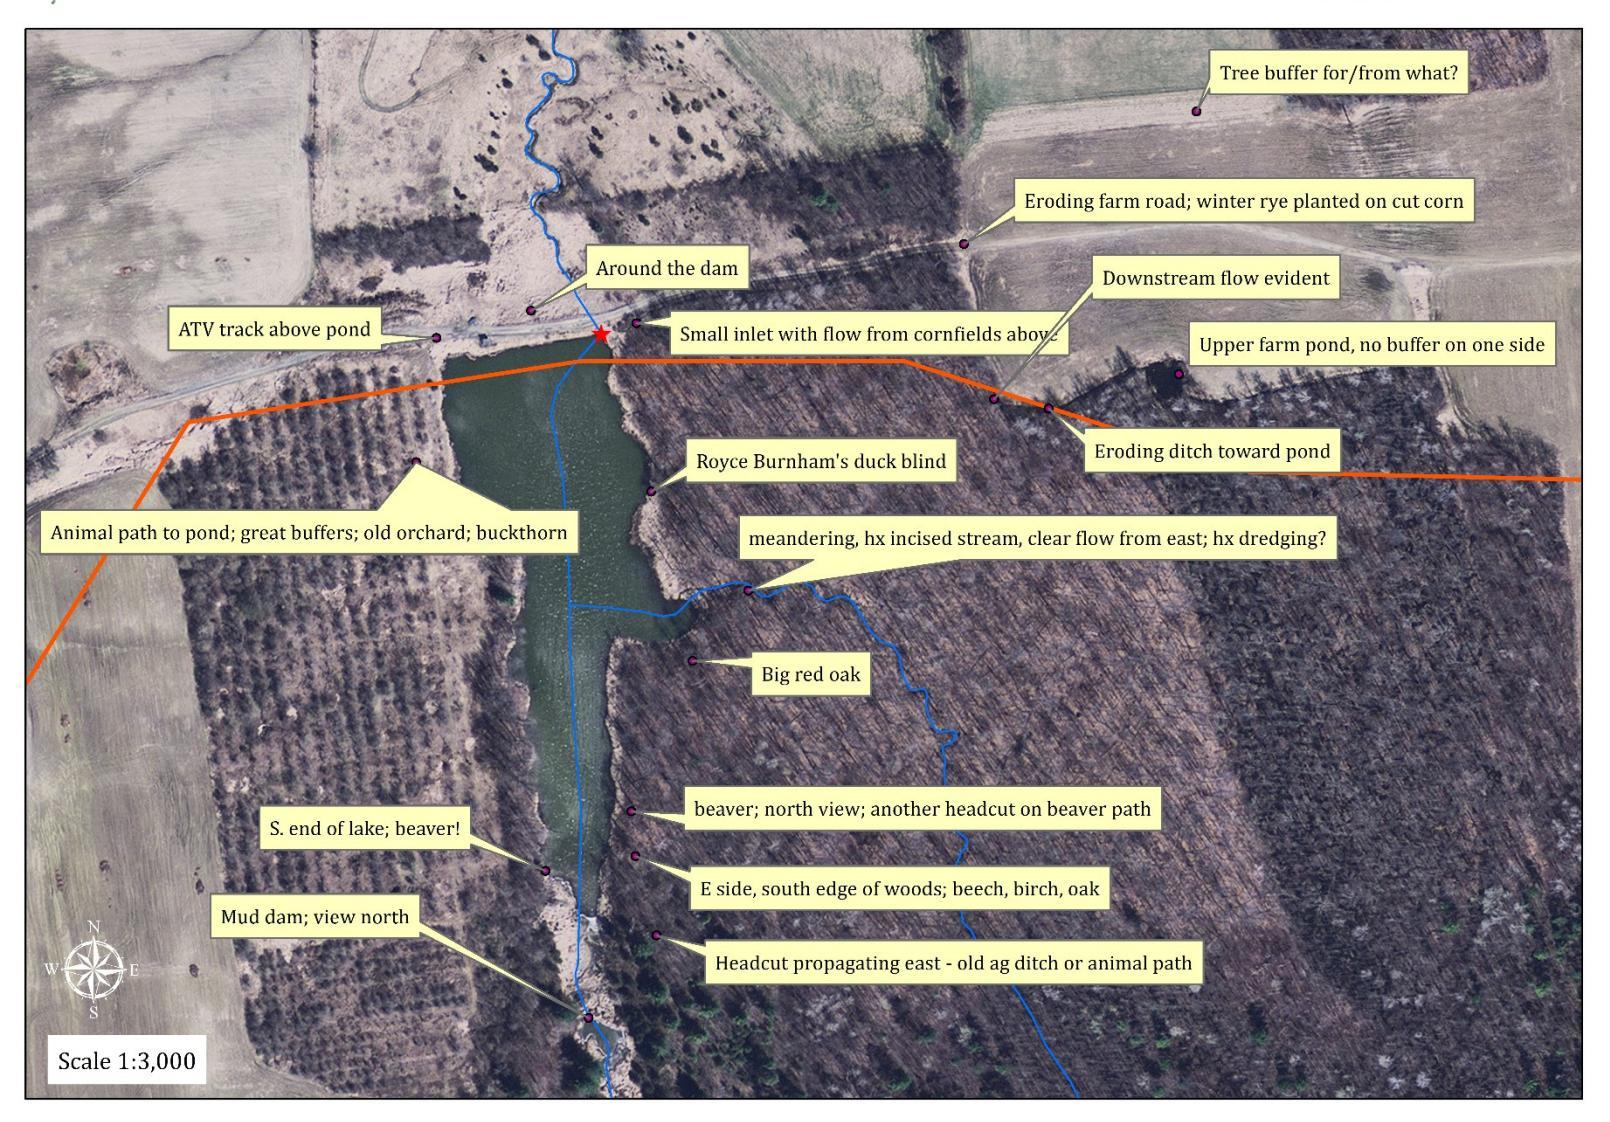
#### Map 7. South Bingham Field Notes

A close examination of current aerial photos indicates that aquatic vegetation similar to that observed in the Douglas Pond also accumulates in this pond seasonally. By November the water in the pond was mostly clear, with minor algae observed in the shallowest areas. Aerial photo analysis and 2' contours derived from LIDAR data indicate that there are flows accumulating on the cultivated fields and draining into the stream that feeds the pond. (Map 7 below).

- 1. Cover cropping observed in both the east and west side corn fields in 2014 is a good step toward slowing runoff into adjacent surface waters.
- 2. Riparian and agricultural buffers Planting perennial buffers along the drainages and increasing the riparian buffer areas along the Beaver Brook before it enters the pond will reduce erosion by slowing flows and will retain nutrients. An example of best management practices on a sloping cornfield adjacent to a wetland/stream is north of Lime Kiln Road in New Haven on the east side of the road.
