# Douglas Pond and S. Bingham Pond Land Use and Water Quality Assessment Cornwall, Vermont

Landslide Natural Resource Planning P O Box 311 East Middlebury, VT 05740

December, 2014

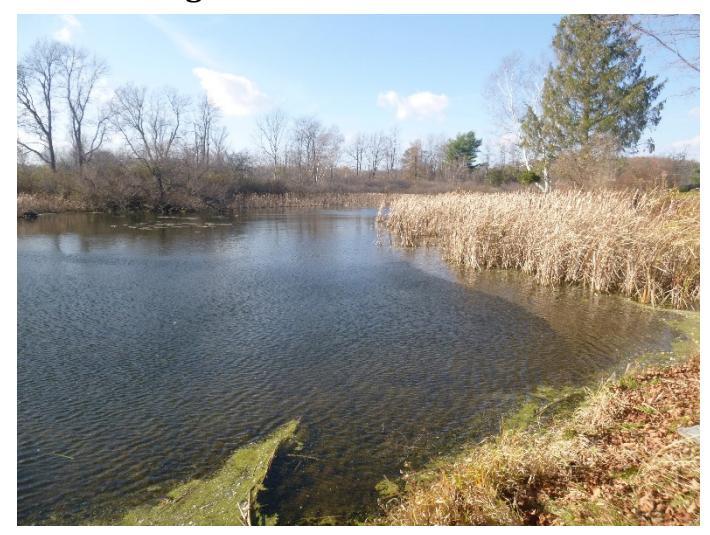
Douglas Pond November, 2014

Residents have voiced a concern over the observed filling in of the pond and the seasonal growth of aquatic vegetation that makes boating and swimming difficult. In August, 2014 the pond was observed to be clogged with plants. Eutrophication – the process by which a pond or lake gradually fills in - can be a natural process or it may be caused by human land uses or exacerbated by them. In order to inexpensively quantify and assess the water quality and swim ability of Douglas Pond, water depths were measured and plant samples from the pond were taken and sent to the State lab for analysis. Measured water depths ranged from 1.4' at the northwest end of the pond to 4.2'at the east end in the vicinity of the raft that the town used to put out for swimming. See Map 5 below. Valerie Ringey Calzini also reported that the leach species in the pond has changed over time from a small black to a larger brown type.

- 7. Dredging many pond owners in Vermont periodically have to remove accumulated sediment in order to maintain pond depths. If residents want to swim in this pond again, dredging will be required.
- 8. Installation of a seasonal dam to allow spring flows to move sediment through the system (suggested by Brian Howlett).
